**City of Fort Lauderdale Project No. P12212, Seawall
Master Plan Summary Report**

TRC Project #: 23FTL017

Jenkins and Charland, Inc. Dba TRC Worldwide Engineering

Summary Report

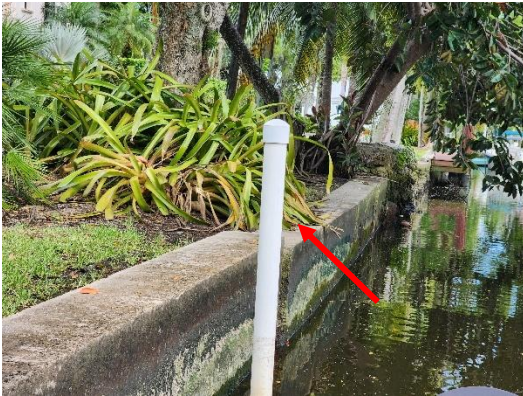
- 1) Displacement: Lateral movement/ rotation was noted in many instances across varying wall types:

**Figure 2.5.1 Lateral Movement/Rotation
(WALL 27)**

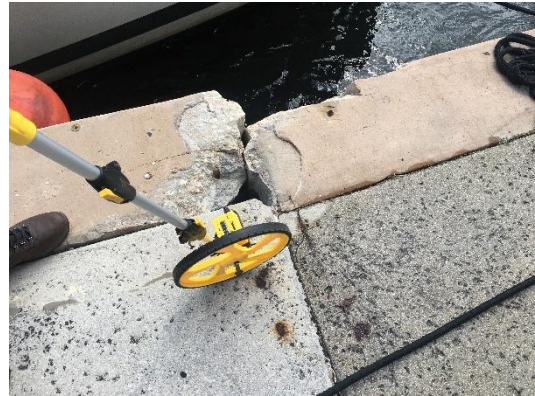
**Figure 2.5.2 Lateral Movement, Separation
(WALL 24)**

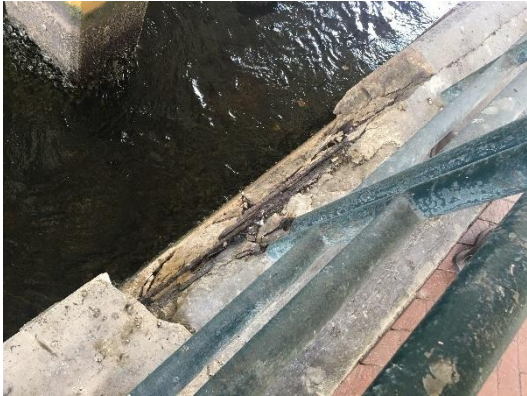
- 2) Element Condition: Piles and Caps were seen to be spalled in various locations with reinforcement corrosion. It was stypical to see hairline cracks along caps and panels.

**Figure 2.5.3 Typical Spall at Cap
(WALL 24)**

Spalls are defined as a loss of concrete via cracking/ delaminating. While spalls can occur due to various reasons, the most common spall seen at these walls was due to corrosive reinforcement. Water infiltrates the concrete and reaches the reinforcement within the specific element, expands, and the concrete spalls. Spall repairs are used to restore section loss or loss of concrete cover over top reinforcing in reinforced concrete components.

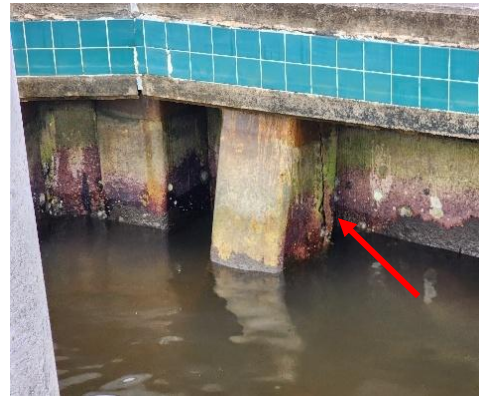
**Figure 2.5.4 T-Pile and Batter Pile Spall
(WALL 41)**

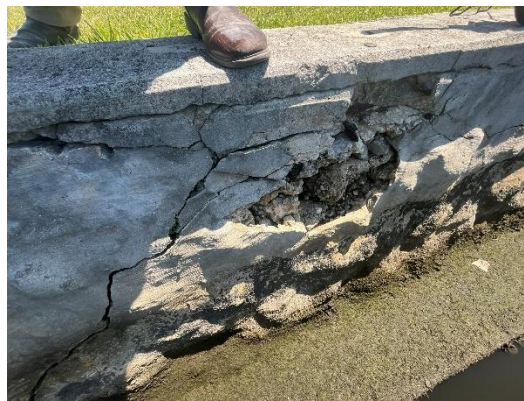
- 3) Section Loss: It was typical to see loss of rock and cracking of coral rock walls.

**Figure 2.5.5 Missing Coral Rock in Wall
(WALL 40)**

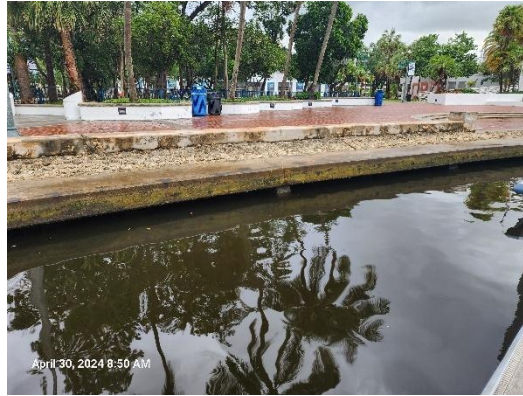
- 4) Elevation Of Wall: Wall elevations were measured to ensure the minimum top of wall elevation of 5.00FT NAVD were met per Ordinance No. C23-05 that was adopted on March 23,2023. Most walls were found to not meet the required elevation.

**Figure 2.5.6 Wall Elevations Below Required Ordinance
(WALL 41)**

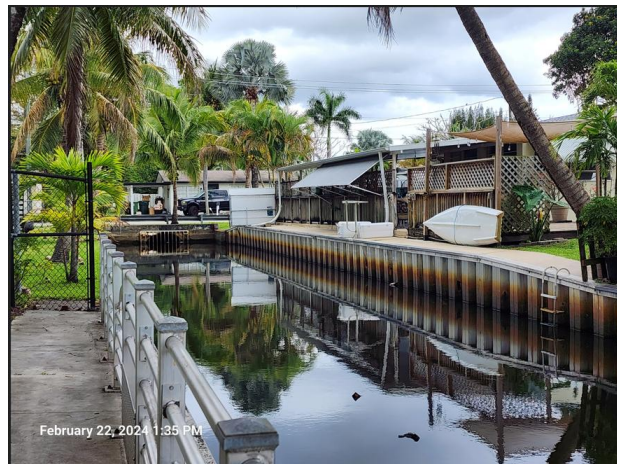
- 5) Channel condition: The wall inspections performed by TRC were limited to above water inspections. Therefore, wall penetration, and the overall groundline in front of the wall could not be taken into consideration for the wall categorizing. The overall view of the channels were looked at and noted if any obstruction (debris) was blocking access to the channel. Additionally, when channels had one direction of entry this was noted in the report for wall access conditions.

**Figure 2.5.7 Channel End
(WALL 36)**

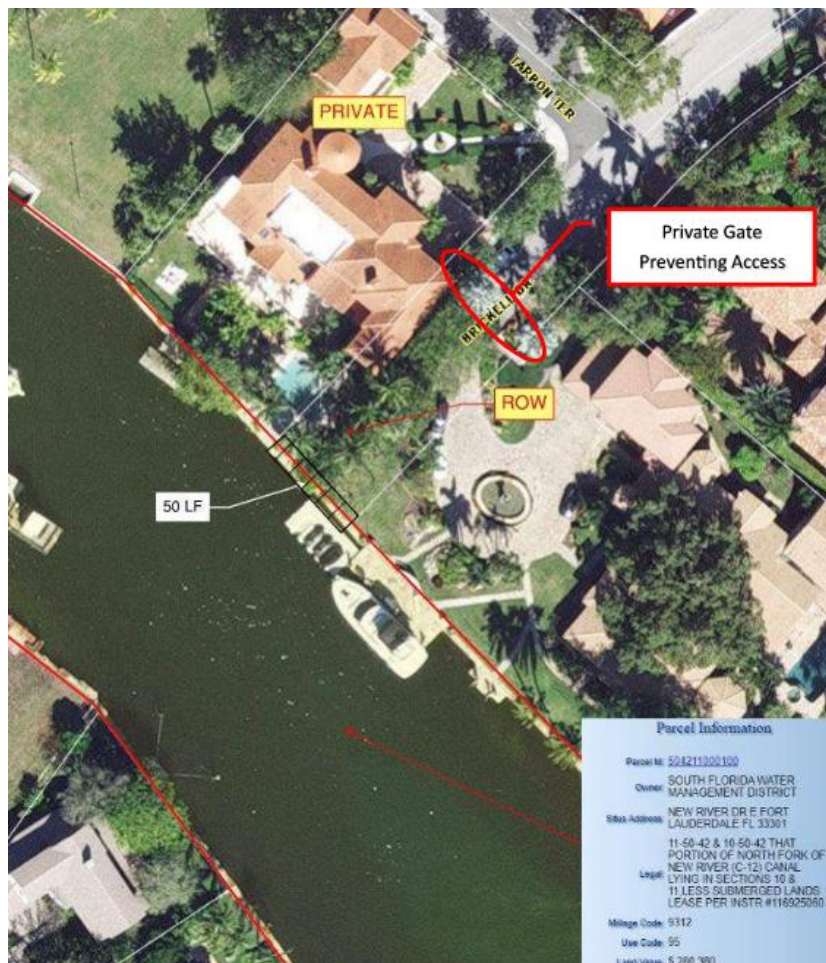
- 1) Access: Seawalls accessible by land requiring access through private property will impact construction. Seawalls such as Seawall 66 are only accessible by crossing through private property, or via the waterway (Figure 2.6.1). Additionally, some walls are found within canals with lower water lines where equipment access may be limited.

Figure 2.6.1 Accessibility Issues (WALL 66)

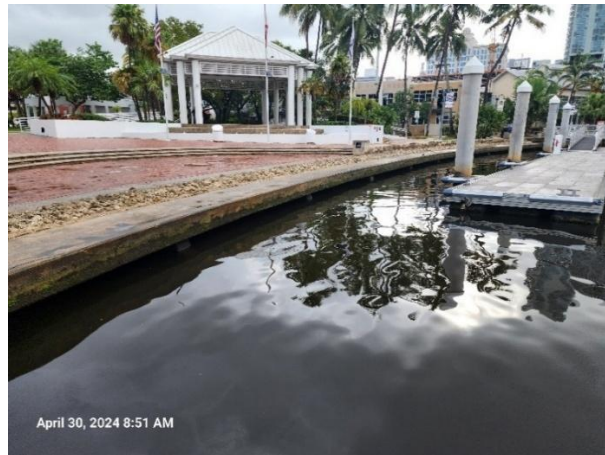
- 2) Type of property behind seawall: Many seawalls support residential and commercial properties, see Figure 2.6.2. Minimizing impacts not only to the condition of the adjacent property but the operations and access to the property are key construction considerations.

**Figure 2.6.2 Wall Supporting Parking and Structure Facilities
(WALL 41)**

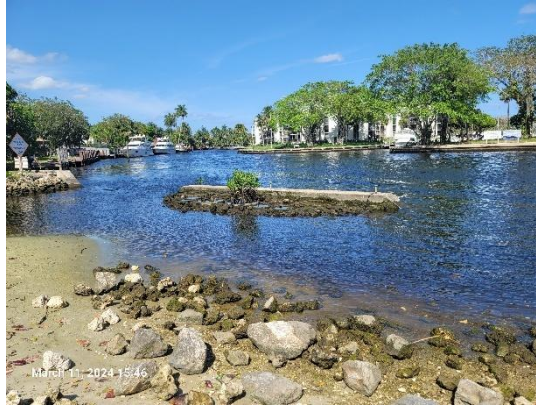
- 7) Environmental sensitivity: Presence of environmentally sensitive resources such as Mangroves may require mitigation.

**Figure 2.6.3 Mangroves
(NORTH END OF WALL 21)**
