**City of Fort Lauderdale Project No. P12212, Seawall
Master Plan Summary Report**

TRC Project #: 23FTL017

Jenkins and Charland, Inc. Dba TRC Worldwide Engineering

Summary Report

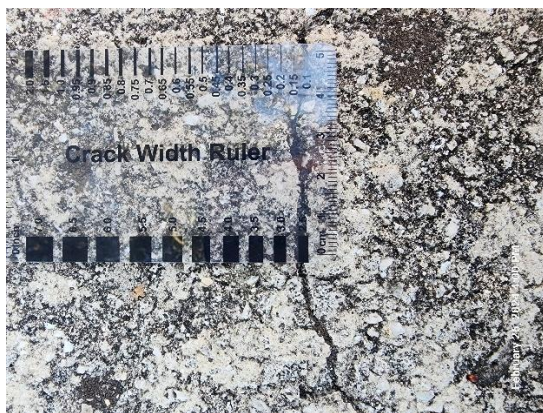
Figure 2.3.1 – Crack Comparator Card

Deficiency locations were measured from the end of seawall. Conditions were confirmed by hand measurements, wheel measurements, and sounding using a hammer or club. Conditions were documented by digital photograph. Crack widths were measured using a crack width comparator card (Figure 2.3.1). Relatively widespread deficiencies were documented as “General Conditions” and quantities based on regular measurements and overall percentage of seawall. Cause of deterioration (i.e. impact spall vs. delamination) were identified where appropriate and any loss of section documented. In all cases, deficiencies were noted in certain terms, such as *shallow spall with no exposed rebar*, *spall with exposed rebar*, *crack with staining*, *crack with efflorescence*, *crack (solid when sounded)*, *crack (hollow when sounded)*. Top of seawall elevations were confirmed in NAVD '88 and Base Flood Elevations confirmed using FEMA Base Flood Maps.

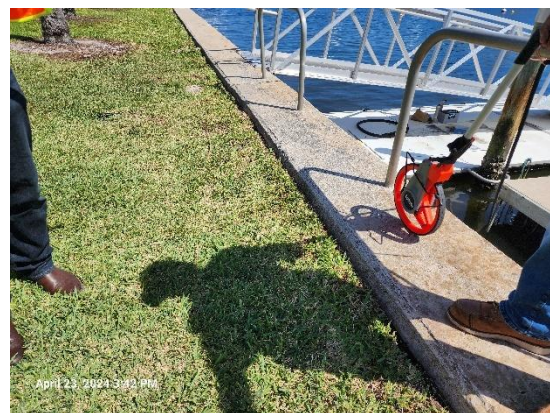
Figure 2.3.2 – Inspectors Stationing

The above water inspection included an inspection of all visible seawall components. These inspections consisted of landside inspections, as well as water inspections, as needed. Variations in seawall type were documented as well as conditions behind the seawall such as facilities, properties, and outfalls. The water inspections were performed from on a boat with a team that consisted of three individuals: two inspectors and a boat captain. Note that not all walls required boat inspections. TRC, with the assistance of the City, performed boat inspections where wall visual inspections were found to be limited by land. Where inspections were performed by boat, one inspector remained in the boat to inspect from the water, and the second inspector walked landside to track the stationing and inspect top of wall caps and surrounding conditions behind the wall. At walls where only a land inspection was required, the inspection team consisted of 1-4 inspectors depending on the wall length.
